# Troubleshooter Guide

**RENOLD**  
Superior Chain Technology

## Transmission Introduction

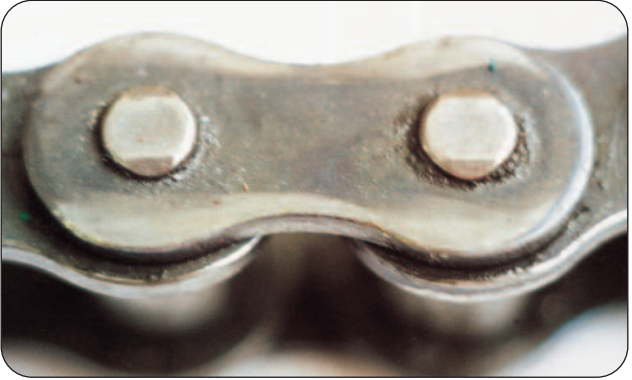
**Figure 1 - Mode of Failure - Alignment**

<b>Application</b>	Simple transmission chain drive.
<b>Failure Mode:</b>	Rubbing wear on the face of the side plates, the end of the side plates and the pin end.
<b>Diagnosis:</b>	The chain has been rubbing against some fixed point on the circuit. This may have caused damage to parts of the guide system or fixtures.
<b>Solution:</b>	Realign the chain drive before the damage to the chain becomes too serious and the chain has to be scrapped.

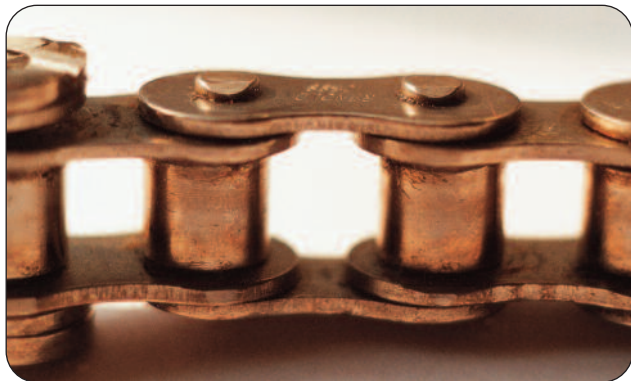
**Figure 2 - Mode of Failure - Abrasion**

<b>Application:</b>	Stainless steel transmission chain used to remove produce from the cooking oil in an automatic fryer.
<b>Failure Mode:</b>	The chain suffered rapid pin/bush wear and pitch extension.
<b>Diagnosis:</b>	When the oil at the delivery end of the fryer was examined, it was found to contain product residue that had been degraded to form very hard burnt particles, that were abrading the chain round parts.
<b>Solution:</b>	Fit replacement chain and introduce a filtration system to the cooking oil to remove the abrasive residue.

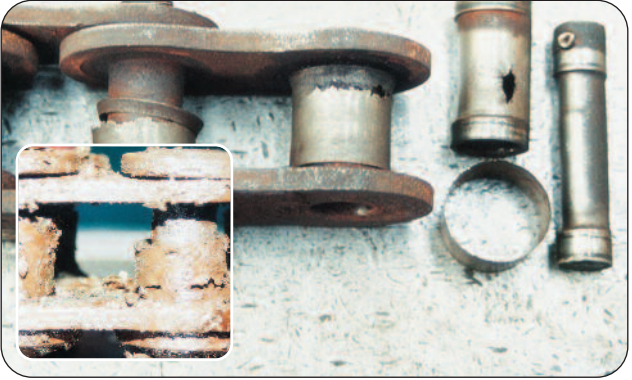
**Figure 3 - Mode of Failure - Corrosion**

<b>Application:</b>	1.75" ANSI simple detachable chain used on a table roll drive in a steel mill.
<b>Failure Mode:</b>	Heavy corrosion and erosion of all parts.
<b>Diagnosis:</b>	Bush and rollers have corroded / worn to a wafer thin condition with corresponding wear on the pins. Plates have a great deal of side wear and are heavily pitted. This chain has been used in an extremely hostile environment subject to high temperatures and water spray.
<b>Solution:</b>	Improve lubrication methods. Consider using a corrosion resistant chain.

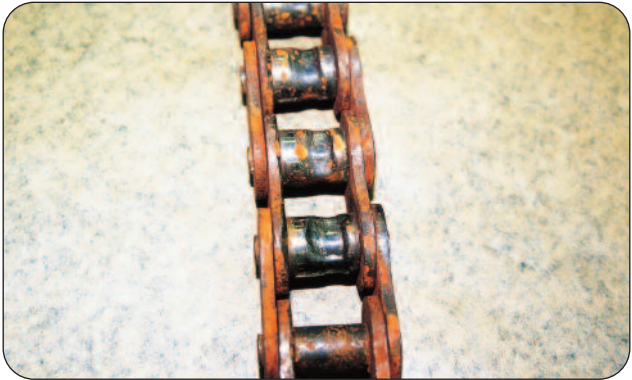
**Figure 4 - Mode of Failure - Corrosion**

<b>Application:</b>	Chain drive used on a barrelling machine.
<b>Failure Mode:</b>	Corrosion.
<b>Diagnosis:</b>	This chain has been used in an environment with water contamination. The chain has not been regularly lubricated and external parts have gradually corroded until the rollers seized. The chain has then proceeded to wear heavily on the rollers.
<b>Solution:</b>	Protect from water if possible. Increase degree of maintenance lubrication.

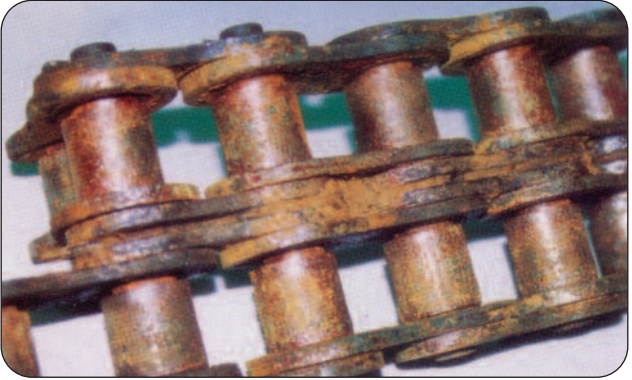
**Figure 5 - Mode of Failure - Corrosion/Erosion**

<b>Application:</b>	1.75" ANSi duplex chain used on a carrier drive in a sugar mill.
<b>Failure Mode:</b>	Heavy corrosion of all the components in the chain.
<b>Diagnosis:</b>	The chain had been operating without any lubricant being applied and was also subject to attack by acidic sugar juice. As a result the chain suffered heavy corrosion and wear.
<b>Solution:</b>	Replace the chain and ensure adequate lubrication is applied. Protect the chain from juice with an appropriate casing.

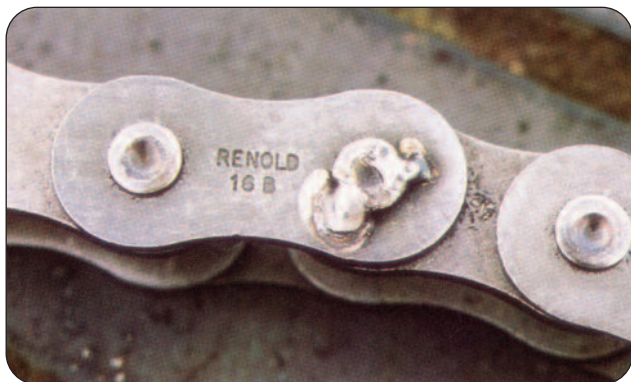
**Figure 6 - Mode of Failure - Cracking**

<b>Application:</b>	1" P BS transmission chain
<b>Failure Mode:</b>	Outer plate cracking
<b>Diagnosis:</b>	A pin has been tac-welded on both sides of an outer plate. The cooling rate after welding resulted in the plate cracking.
<b>Solution:</b>	No welding should be carried out after supply as this can cause plate cracking, distortion and stress relieving.

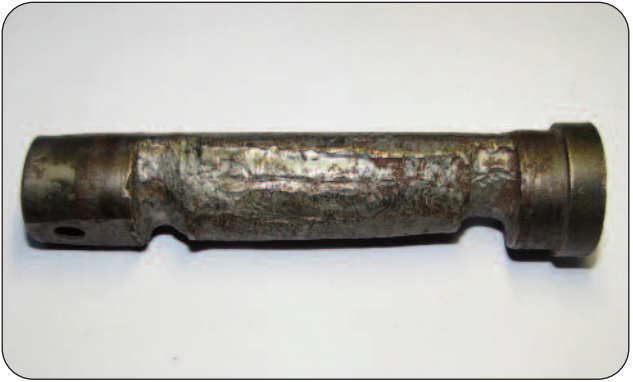
**Figure 7 - Mode of Failure - Erosion**

<b>Application:</b>	Bucket elevator chain
<b>Failure Mode:</b>	Dry cavitation erosion caused by particulate debris
<b>Diagnosis:</b>	Pin erosion when handling dry materials which act like a fluid when in contact with the chain, this type of wear is common on elevator chain handling cement.
<b>Solution:</b>	Once the wear pockets are established the rate of wear tends to accelerate. Sealed joint chains are recommended to increase the chain life.

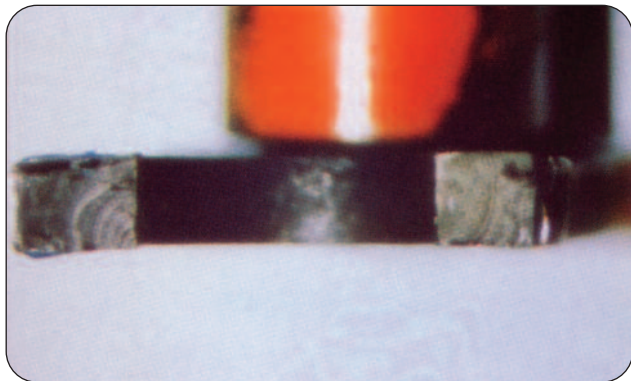
**Figure 8 - Mode of Failure - Fatigue**

<b>Application:</b>	Transmission chain was used in a highly impulsive load application.
<b>Failure Mode:</b>	Inner plate suffered a fatigue failure.
<b>Diagnosis:</b>	Due to the high impulsive loading, a crack started at the edge of the plate hole and crack propagation occurred, resulting in a 'classic' fatigue failure.
<b>Solution:</b>	Eliminate high impulsive loading or select larger pitch chain.

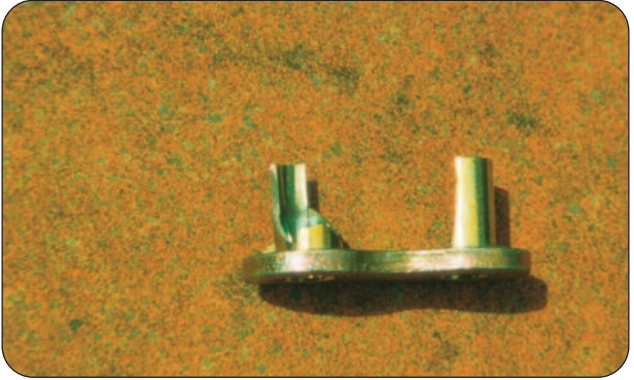
**Figure 9 - Mode of Failure - Fracture**

<b>Application:</b>	1.25" P BS zinc plated chain used in a water environment.
<b>Failure Mode:</b>	Bushes fractured on assembly
<b>Diagnosis:</b>	Customer supplied zinc plated bushes for assembly. When assembled the bushes broke into several fragments due to hydrogen embrittlement as they had not been de-embrittled after plating.
<b>Solution:</b>	Ensure correct de-embrittlement treatment is carried out immediately after plating.

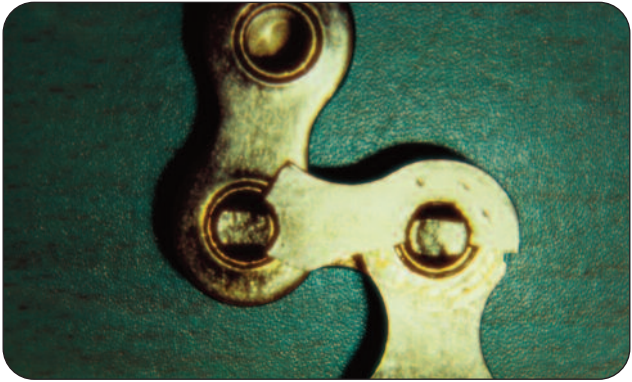
**Figure 10 - Mode of Failure - Fracture**

<b>Application:</b>	1" P BS chain.
<b>Failure Mode:</b>	Plates fractured when chain working load was applied.
<b>Diagnosis:</b>	Chain had been zinc plated by customer without carrying out any de-embrittlement treatment which resulted in chain failure due to hydrogen embrittlement.
<b>Solution:</b>	Chain should be initially zinc plated before assembly by Renold.

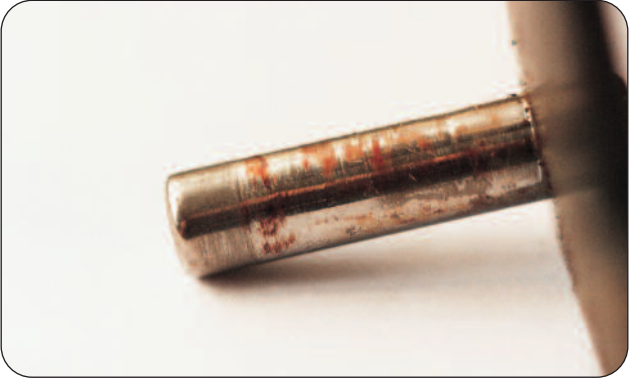
**Figure 11 - Mode of Failure - Fretting Corrosion**

<b>Application:</b>	Transmission chain with pushers at intervals to control the conveying of boxes of breakfast cereal.
<b>Failure Mode:</b>	Severe wear of one pin of the pusher attachment and red deposit indicating fretting corrosion.
<b>Diagnosis:</b>	The pusher attachment was designed 50.8mm pitch to fit on a chain of 25.4mm pitch and operate on sprockets designed for 25.4mm pitch chains. This caused very high pressure on one pin of the attachment link which squeezed out most of the lubricant. This resulted in the marginal lubrication situation required to produce fretting corrosion.
<b>Solution:</b>	<ol style="list-style-type: none"> <li>1. Use specially designed sprocket teeth with relieved tooth pocket at the attachment position.</li> <li>2. Employ a high performance lubricant with solid residue to prevent squeeze-out.</li> </ol>

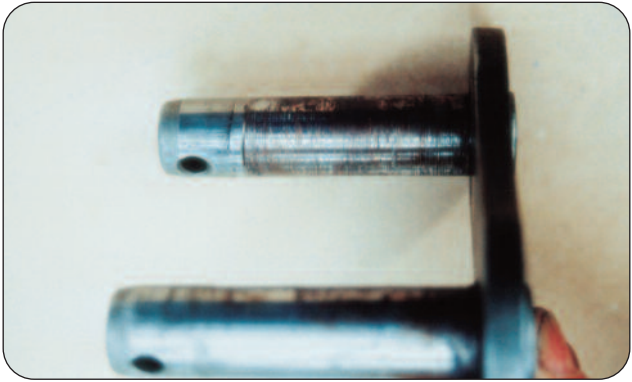
**Figure 12 - Mode of Failure - Galling**

<b>Application:</b>	2.5" P ANSI chain used on a lifting application.
<b>Failure Mode:</b>	The bearing areas have suffered galling where the surfaces have articulated and then fused together.
<b>Diagnosis:</b>	Very high bearing pressures had been experienced in this lifting application. The effect being that the lubricant had failed and galling had occurred on articulation.
<b>Solution:</b>	Use a high quality, high pressure lubricant and ensure that a film of lubricant is maintained between mating surfaces.

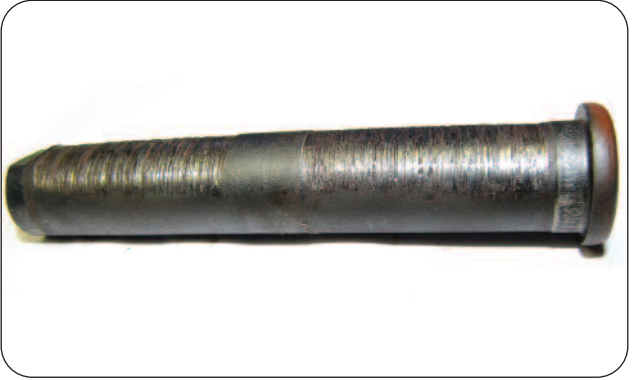
**Figure 13 - Mode of Failure - Galling**

<b>Application:</b>	Large Pitch Duplex Chain
<b>Failure Mode:</b>	Severe galling due to high bearing pressures and lack of lubrication between articulating surfaces resulting in surfaces fusing together.
<b>Diagnosis:</b>	Lubrication failure resulted in surfaces fusing together under high bearing pressure. This galling process is also referred to as 'micro welding'.
<b>Solution:</b>	Ensure adequate means of lubrication.

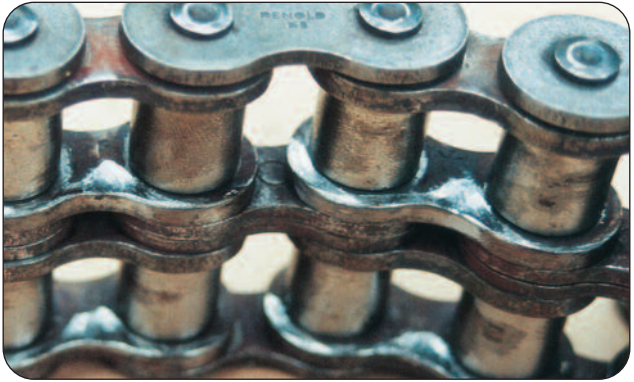
**Figure 14 - Mode of Failure - Lubrication & Alignment**

<b>Application:</b>	1" P BS duplex chain driving a flywheel on a 400 Tonne press.
<b>Failure Mode:</b>	Excessive wear. Chain jumping teeth causing tooth rounding.
<b>Diagnosis:</b>	Examination of the chain showed no lubrication had been applied in the 6 months service life. The loads involved require a minimum of oil sump lubrication. In addition to this the centre distance was higher than recommended and the sprockets were out of line.
<b>Solution:</b>	Improve the lubrication method. Consider hardening the driver teeth. Correct the drive alignment.

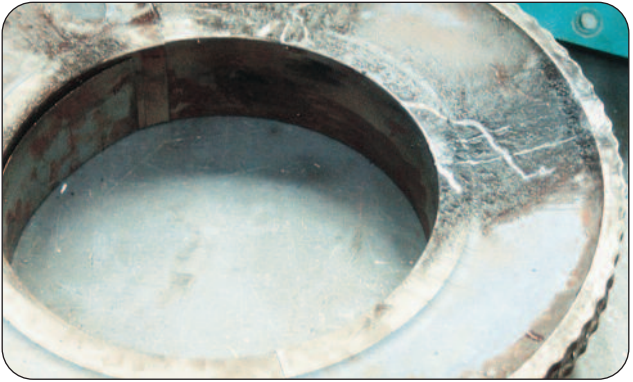
**Figure 15 - Mode of Failure - Lubrication & Alignment**

<b>Application:</b>	1" P BS duplex chain driving a flywheel on a 400 Tonne press.
<b>Failure Mode:</b>	Excessive wear. Chain jumping teeth causing tooth rounding.
<b>Diagnosis:</b>	Examination of the chain showed no lubrication had been applied in the 6 months service life. The loads involved require a minimum of oil sump lubrication. In addition to this the centre distance was higher than recommended and the sprockets were out of line.
<b>Solution:</b>	Improve the lubrication method. Consider hardening the driver teeth. Correct the drive alignment.

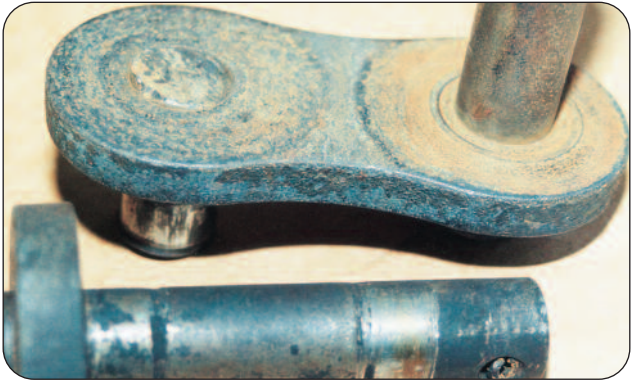
**Figure 16 - Mode of Failure - Lubrication & Alignment**

<b>Application:</b>	Special 2.5" P ANSI simple chain used for conveying in a mine.
<b>Failure Mode:</b>	Slip fit connecting link pin suffered a fatigue failure.
<b>Diagnosis:</b>	The joint was extremely dry and showed no signs of lubrication. The joint showed heavy galling with the presence of surface corrosion products. Subsequent investigation revealed that the chain had been running in water, but more significantly that the user had opened out the holes on the loose plate of the No 58 joint to make assembly easier. This caused the fatigue failure experienced.
<b>Solution:</b>	Provide a better lead in on the pin to enable the user to assemble more easily. Reconsider lubrication regime.

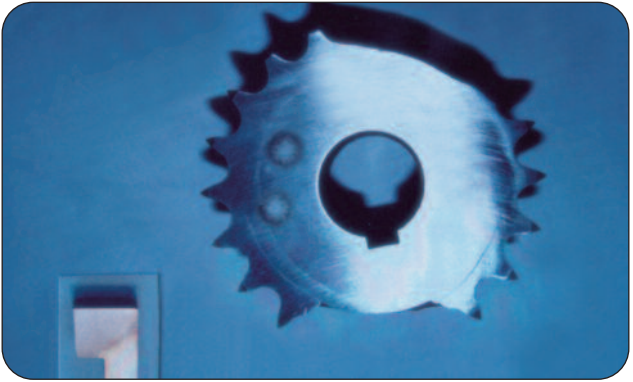
**Figure 17 - Mode of Failure - Material cracking below teeth**

<b>Application:</b>	0.5" P BS 20 tooth sprocket.
<b>Failure Mode:</b>	Material cracking below teeth.
<b>Diagnosis:</b>	Customer had flame hardened the teeth incorrectly. Due to the differential rate of cooling resulting from the sprocket section, cracking occurred.
<b>Solution:</b>	Sprockets to be supplied with teeth already flame hardened by Renold.

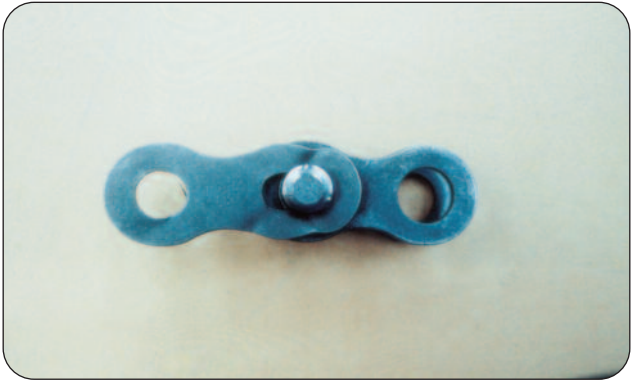
**Figure 18 - Mode of Failure - Overload**

<b>Application:</b>	1.5" P BS chain test sample.
<b>Failure Mode:</b>	Outer plates have been permanently stretched due to the high load.
<b>Diagnosis:</b>	Good example of overload.
<b>Solution:</b>	Correctly size the chain for the application.

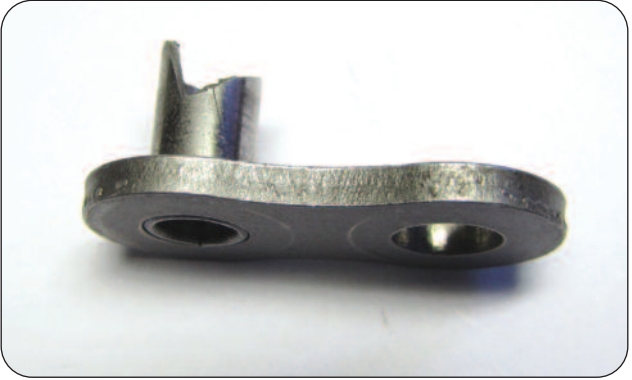
**Figure 19 - Mode of Failure - Overload**

<b>Application:</b>	Simplex transmission chain used in severe overload situation.
<b>Failure Mode:</b>	Severe damage to transmission chain pin and collapse of the chain bush.
<b>Diagnosis:</b>	Bush fatigue failures occur as the result of service overloads. The crack originates at a point on the inside surface of the bush and it progresses longitudinally or circumferentially until it cracks completely. Failures may also be caused by improper sprocket manufacture or selection.
<b>Solution:</b>	Bush fatigue can be overcome by eliminating overloads, increasing sprocket size and changing sprockets that are badly worn or oversized on the bottom diameter.

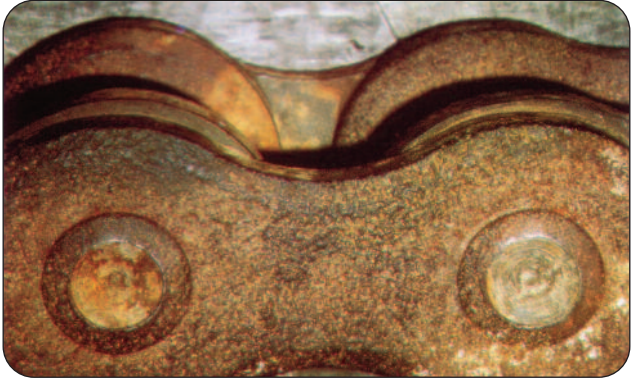
**Figure 20 - Mode of Failure - Pitting Corrosion**

<b>Application:</b>	Duplex transmission chain used in severe overload situation.
<b>Failure Mode:</b>	Severe damage to transmission chain pin and collapse of the chain bush.
<b>Diagnosis:</b>	Excessive overload on the chain led to the collapse of the bush and damage to the pin.
<b>Solution:</b>	Correctly size the chain for the application.

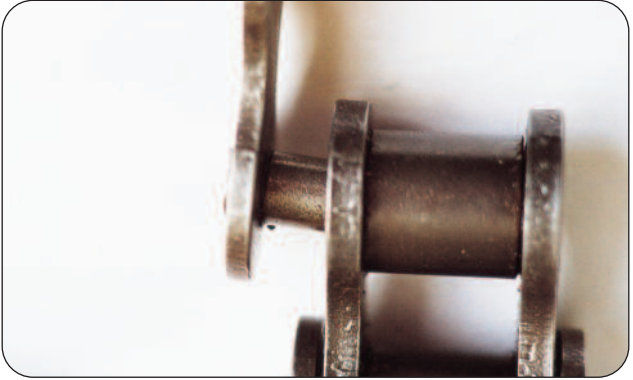
**Figure 21 - Mode of Failure - Riveting Failure**

<b>Application:</b>	Simple transmission chain drive to a machine.
<b>Failure Mode:</b>	One outer link has become detached and the pin bent.
<b>Diagnosis:</b>	The loose side plate of a No 107 connecting link has become detached due to inadequate riveting on site. The pin has moved out and jammed in position allowing the chain to continue working until the failure was noticed.
<b>Solution:</b>	Replace the No 107 link and ensure that the pins are adequately riveted.

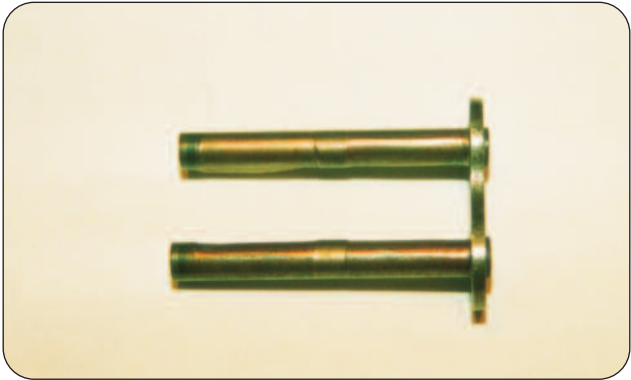
**Figure 22 - Mode of Failure - Wear**

<b>Application:</b>	1.5" P BS duplex chain.
<b>Failure Mode:</b>	Pin bearing areas worn. Note position of intermediate plates is clearly visible.
<b>Diagnosis:</b>	Over a long period of time the pins have gradually worn until the chain elongation has reached 2%
<b>Solution:</b>	Monitor chain extension regularly.

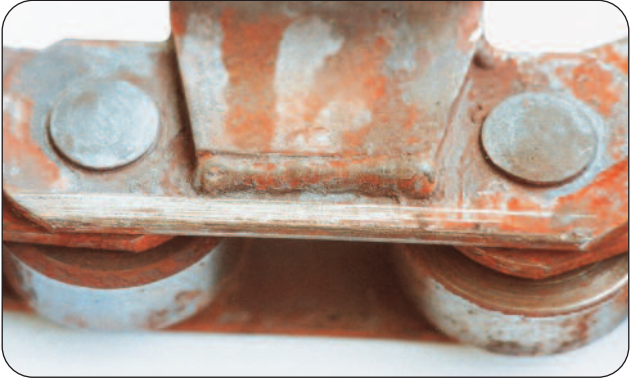
**Figure 23 - Mode of Failure - Alignment**

<b>Application:</b>	134,000 N breaking load chain operating on a slat conveyor with slats bolted across the K attachments.
<b>Failure Mode:</b>	Side plates showed severe rubbing marks along one edge.
<b>Diagnosis:</b>	The side plate edges have been rubbing against some fixed point on the conveyor structure, probably the edge of the guide tracks. The effect of this would be to wear away the side plate and to increase the drive power and chain tension.
<b>Solution:</b>	Determine the point of contact and realign the chain to prevent rubbing. It may be necessary to check and adjust the track to ensure levels are correct across the two strands.

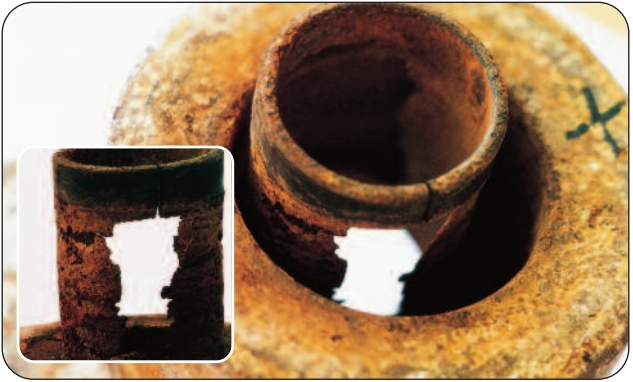
**Figure 24 - Mode of Failure - Abrasion**

<b>Application:</b>	Conveyor chain used in handling wet china clay.
<b>Failure Mode:</b>	Severe wear between the chain bush and roller in a china clay extraction plant.
<b>Diagnosis:</b>	Abrasive residues (Quartz) in the clay from the original granite material causing wear to the surfaces.
<b>Solution:</b>	Specify Renold Chain with extra hard surface materials to be included in the manufacture of chain round parts.

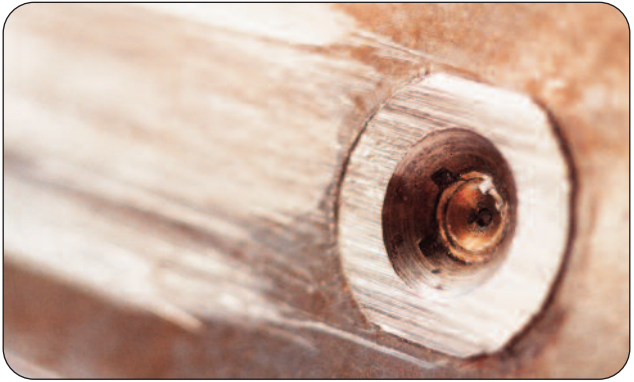
**Figure 25 - Mode of Failure - Alignment**

<b>Application:</b>	Can steriliser chain.
<b>Failure Mode:</b>	Wear to the pin ends has removed the rivet security and the outer plate has become detached.
<b>Diagnosis:</b>	Differential wear to the chains has caused the vertical strands to move to the side and contact the guides. The guides are of similar hardness to the pin ends and the pin ends have worn away releasing the outer side plate.
<b>Solution:</b>	Fit side guides that are softer than the pin ends. Also consider fitting a rubbing block at intervals along the chain to protect the pin end.

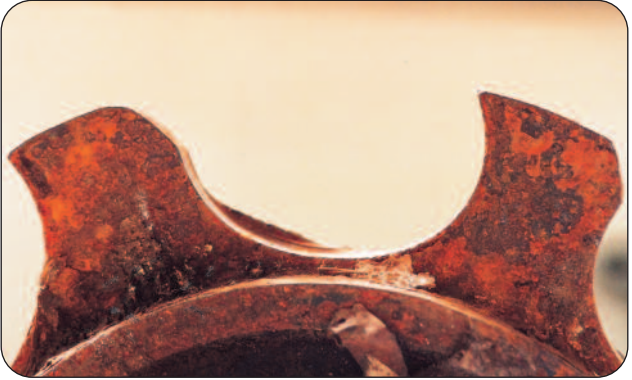
**Figure 26 - Mode of Failure - Alignment**

<b>Application:</b>	Cast iron sprockets fitted to chain scraper conveyors used for cleaning the primary screens at a sewage treatment plant.
<b>Failure Mode:</b>	Sprocket teeth suffered severe wear over a six month period and several teeth were so weakened that they fractured across the thinnest section.
<b>Diagnosis:</b>	The teeth were machined to a thinner section to accommodate flanged rollers on the chain and the chain was allowed to run out of line which resulted in only part contact on the sprockets. The resulting high pressure caused the rapid wear shown on the photograph.
<b>Solution:</b>	Replace the sprockets and realign the chain to ensure full contact between the chain roller and the sprocket teeth.

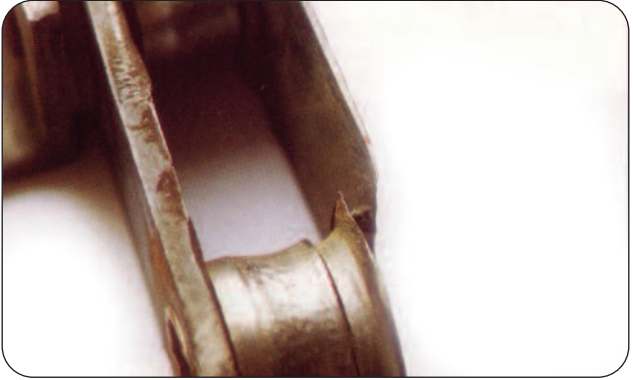
**Figure 27 - Mode of Failure - Alignment**

<b>Application:</b>	Cement conveyor chain
<b>Failure Mode:</b>	Wear on the chain side plate has occurred and the side plate has failed under load.
<b>Diagnosis:</b>	The chain has been allowed to run out of line and the sprocket teeth have worn away one side plate to the point where the side plate became so thin it failed under load.
<b>Solution:</b>	The chain has been damaged beyond repair and must be replaced. Chain tracks must be checked and sprocket alignment corrected before operating with the new chain.

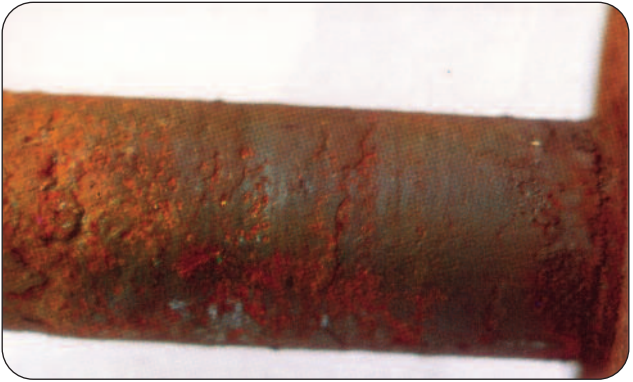
**Figure 28 - Mode of Failure - Corrosion at High Temp**

<b>Application:</b>	Chain drive to rollers in a continuous casting machine.
<b>Failure Mode:</b>	Lubrication to the chain has been ineffective and has allowed chain components to corrode.
<b>Diagnosis:</b>	Lubrication has been ineffective and has not penetrated into the chain round parts
<b>Solution:</b>	Replace the chain with new chain, initially lubricated with a correctly selected lubricant for the temperature and environment.

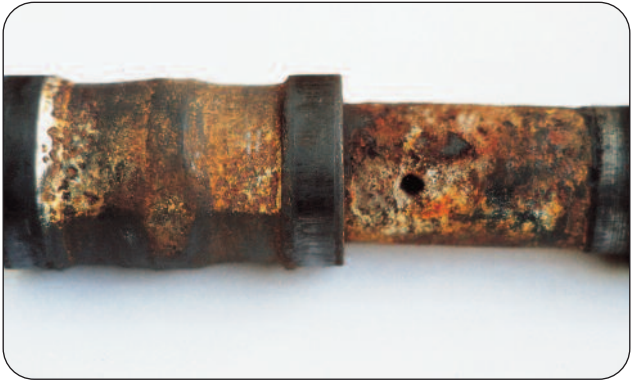
**Figure 29 - Mode of Failure - Corrosion/Erosion**

<b>Application:</b>	Heavy duty chain used on a slat conveyor carrying cut sugar cane into a sugar factory.
<b>Failure Mode:</b>	Severe corrosion and wear of pin and bush surfaces.
<b>Diagnosis:</b>	Chain pin and bush were supplied drilled for grease gun lubrication. No lubrication has been applied and the surfaces have been subjected to unprotected corrosion / erosion by acidic sugar juice and sand contamination.
<b>Solution:</b>	Replace the chain and ensure that the grease gun lubrication feature is regularly used.

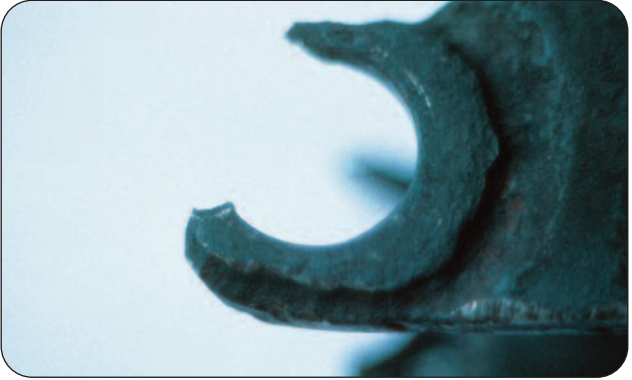
**Figure 30 - Mode of Failure - Corrosion/Erosion**

<b>Application:</b>	Threading chain for passing finished steel strip through the final washing and finishing process.
<b>Failure Mode:</b>	Severe erosion of material from areas of the chain leading to weakening and tensile failure.
<b>Diagnosis:</b>	Sequence of environments between caustic, water and air at high pressure caused erosion / corrosion of the side plates which reduced the section side plates leading to tensile failure.
<b>Solution:</b>	Protection of the chain by either zinc plating or shielding to prevent the erosion.

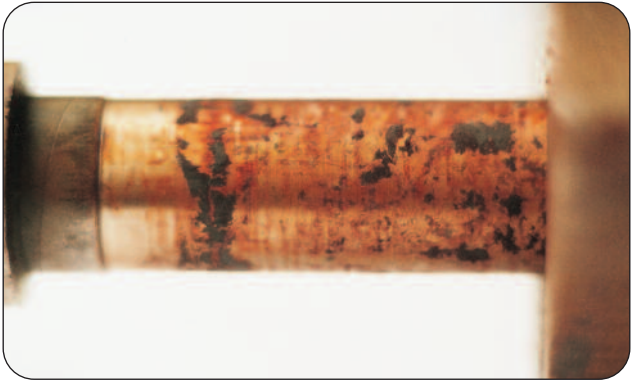
**Figure 31 - Mode of Failure - Fretting**

<b>Application:</b>	Tilt tray sorter chain used in baggage handling in the baggage hall of a major airport.
<b>Failure Mode:</b>	Chain pins and bi-planar block show scoring and heavy red deposit indicating fretting corrosion.
<b>Diagnosis:</b>	Fretting corrosion caused by marginal lubrication, where the lubricant present is insufficient to prevent the asperities on each component rubbing together.
<b>Solution:</b>	Every pin should be removed and all traces of abrasive red oxide removed. The chain should then be operated in an improved lubrication regime.

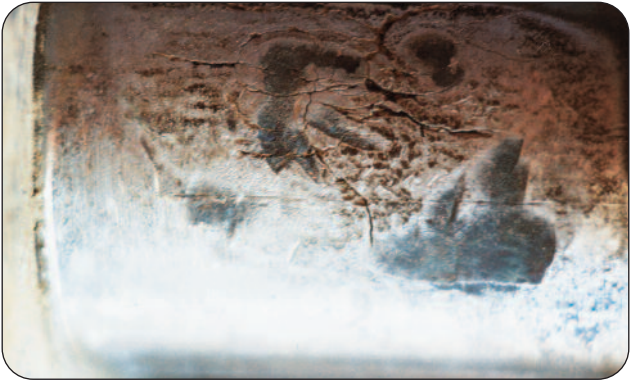
**Figure 32 - Mode of Failure - Impact & alignment**

<b>Application:</b>	Gravity bucket conveyor handling hot cement in a cement works.
<b>Failure Mode:</b>	Heavy surface cracking on the surface of the bushes and abrasion of the inner faces of the side plates.
<b>Diagnosis:</b>	This problem appears to be caused by heavy impact on the bushes. The abrasion on the side plates suggests that the chain is riding up onto the top of the sprocket teeth and then dropping into engagement.
<b>Solution:</b>	Initially the alignment between the chain and the sprockets should be checked. If this is correct then the remaining alignments should be checked, i.e. sprocket centres, levels, chain centres, etc.

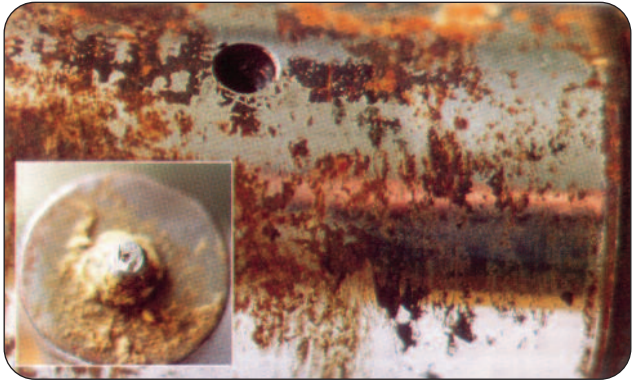
**Figure 33 - Mode of Failure - Lack of Lubrication**

<b>Application:</b>	Heavy duty conveyor in a cement works.
<b>Failure Mode:</b>	Lubricant has not penetrated into the pin/bush surface through the grease gun lubrication facilities in the pin, causing damage to surfaces.
<b>Diagnosis:</b>	The grease nipple has been allowed to become clotted with cement dust which has prevented grease entering the pin, leading to fretted pin surface.
<b>Solution:</b>	More regular lubrication prevents cement setting in grease nipple. Clean out pin and grease nipples on a regular basis.

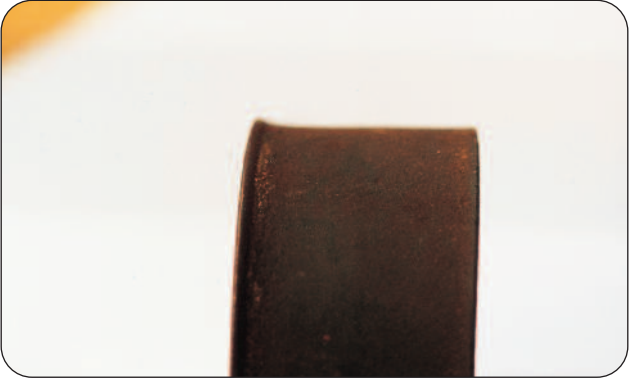
**Figure 34 - Mode of Failure - Misalignment**

<b>Application:</b>	Conveyor chain roller profile after use on a twin strand slat conveyor.
<b>Failure Mode:</b>	Eccentric wear across the face of the roller has caused a lip on one side.
<b>Diagnosis:</b>	The chain has run to one side to the degree where the roller edge has been over the edge of the chain track. The effect of this type of situation is to increase the roller face wear rate by only using part of the face width to carry the loads.
<b>Solution:</b>	Re-align the chain to run correctly on the chain tracks. In the failure shown the chain could be reused with the lip ground off, providing the roller is a sintered through hardened type. Otherwise the chain should be replaced.

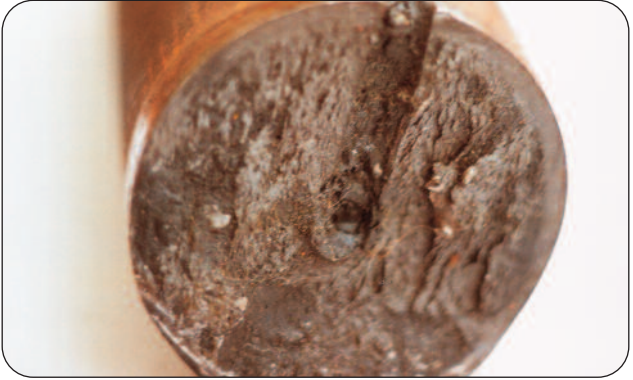
**Figure 35 - Mode of Failure - Misalignment**

<b>Application:</b>	Heavy duty gravity bucket conveyor chain operating in a cement works.
<b>Failure Mode:</b>	The extended bearing pin has failed across the hole which was drilled to allow lubricant into the outboard roller.
<b>Diagnosis:</b>	The chain has moved sideways until one of the rollers has fouled the conveyor structure causing the extended pin to fail. The cross section is interesting in that the fine grained hardened case and the coarse grained ductile core can clearly be seen.
<b>Solution:</b>	The circuit of the conveyor should be checked to find the contact point. The conveyor should be checked to find and correct the reason for the movement to the side.

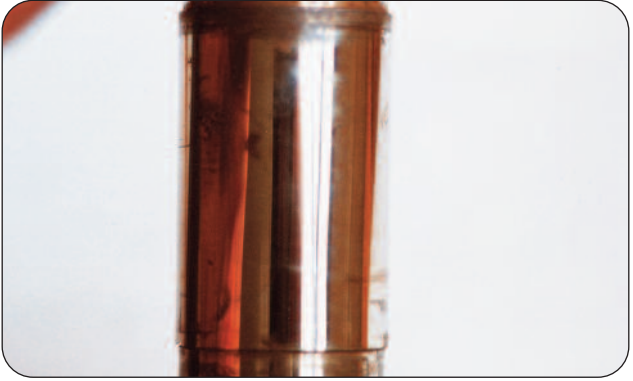
**Figure 36 - Mode of Failure - None**

<b>Application:</b>	107,000 N breaking load hollow pin.
<b>Failure Mode:</b>	None.
<b>Diagnosis:</b>	A correctly lubricated component.
<b>Solution:</b>	-

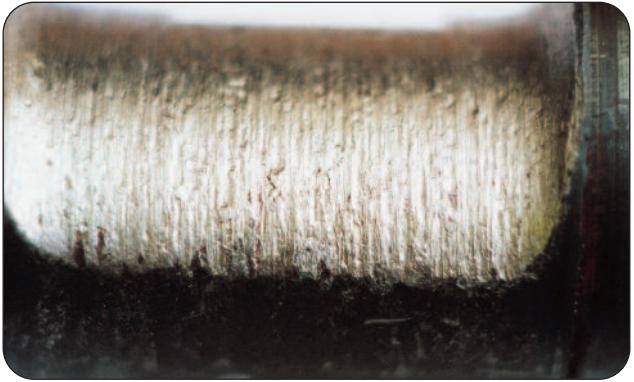
**Figure 37 - Mode of Failure - Overheating**

<b>Application:</b>	Stainless steel chain renewed in an oven operating at a high temperature.
<b>Failure Mode:</b>	The replacement chain wore severely after a short time resulting in the removal for examination.
<b>Diagnosis:</b>	At the same time as replacing the chain, heat trap doors had been fitted which saved heat loss but increased the oven temperature to a level above the acceptable working value for the chain.
<b>Solution:</b>	Return to the previous method of working or accept a much reduced chain life. Heat resisting steels are a possibility.

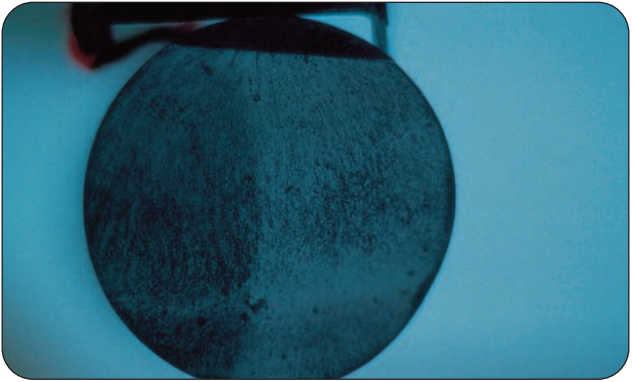
**Figure 38 - Mode of Failure - Overload**

<b>Application:</b>	Extended pin fitted to chain to carry an outboard roller.
<b>Failure Mode:</b>	Sudden shock overload has caused the pin to fail.
<b>Diagnosis:</b>	The extended pin has failed due to overload or shock loading. The failure has initiated at the corner of the flat on the pin. The "river markings" flowing away from the crack initial point can be clearly seen.
<b>Solution:</b>	Determine the reason for the shock / overload and either remove the cause or redesign the pin to carry the load.

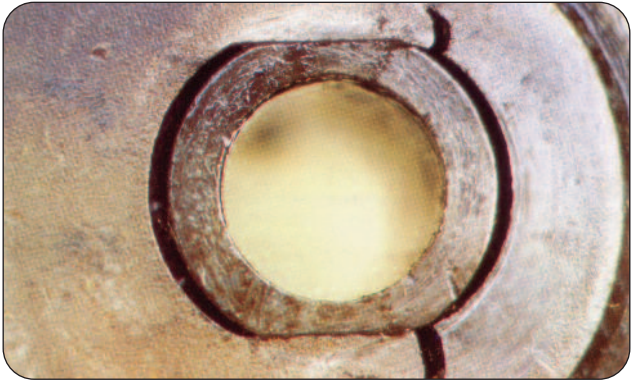
**Figure 39 - Mode of Failure - Overload**

<b>Application:</b>	Used on a scraper conveyor in a cement works.
<b>Failure Mode:</b>	Inner plates have failed around the bush hole with cracks initiating from the corner caused by the flatted pin.
<b>Diagnosis:</b>	The chain has been severely overloaded in tension causing plastic elongation of the bush hole.
<b>Solution:</b>	Replace the chain and determine the cause of the overload. IF it is not possible to remove the source of the overload then the chain should be reselected and a larger chain installed.

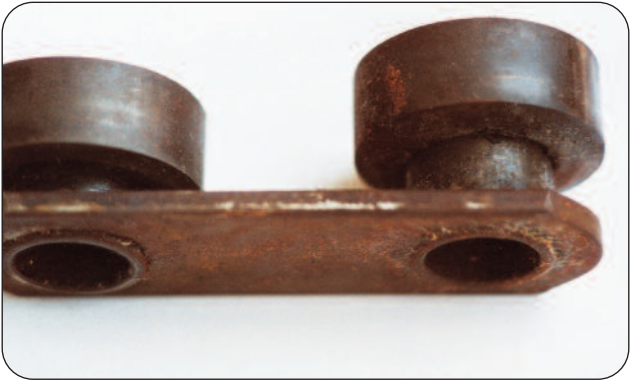
**Figure 40 - Mode of Failure - Roller Seizure**

<b>Application:</b>	Chain used in an oven conveying system.
<b>Failure Mode:</b>	Rollers seized on bushes producing flats on roller outside diameters.
<b>Diagnosis:</b>	The grease lubrication used on the chain was not suitable for the oven temperature and during operation the grease 'carbonised' causing seizure of the rollers.
<b>Solution:</b>	Apply a light flushing oil to the chain to clean out the residue of carbon. If this is not successful then the chain must be replaced and lubricated with an oil compatible with the oven operating temperature.

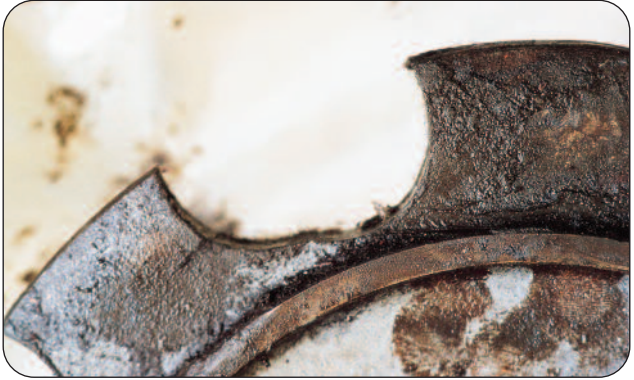
**Figure 41 - Mode of Failure - Sprocket tooth wear**

<b>Application:</b>	Sprockets fitted at the end of a conveyor.
<b>Failure Mode:</b>	Severe hooking wear of the sprocket teeth has been compounded with a second phase of hooked wear.
<b>Diagnosis:</b>	The original chain and sprockets have followed normal wear patterns with hooked wear of the sprocket teeth and pitch elongation of the chain. A new chain has then been fitted to the old wheels which have a worn tooth form incompatible with the pitch of the new chain. The result is severe secondary wear of the sprocket teeth and probably very rapid chain pitch extension.
<b>Solution:</b>	Always check the condition of the existing sprocket teeth before fitting a new chain to any system. In this case the sprockets must be renewed and the chain checked for damage.

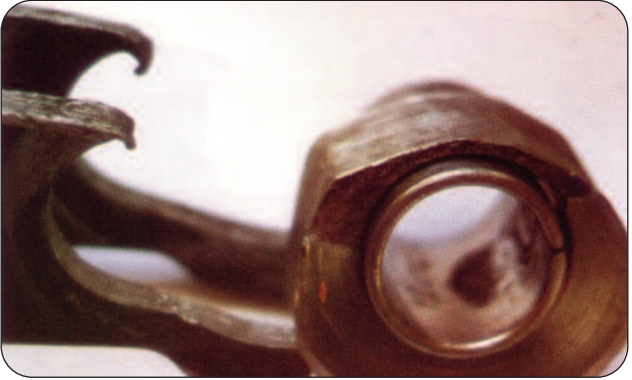
**Figure 42 - Mode of Failure - System Assembly**

<b>Application:</b>	Chain is used with suspended loads from carriers bolted through the hollow bearing pins.
<b>Failure Mode:</b>	The inner side plates and roller have severely worn to the degree that the bush has broken out of the end of the side plate.
<b>Diagnosis:</b>	The assembly of carriers through hollow bearing pins has caused the inner link to be closed onto the roller, preventing roller rotation. The roller outside diameter has worn on one side due to sliding and allowed the side plates to slide on the chain tracks and subsequently wear has caused side plate failure.
<b>Solution:</b>	Replace chain and ensure that carriers are correctly assembled without closing up chain side plates.

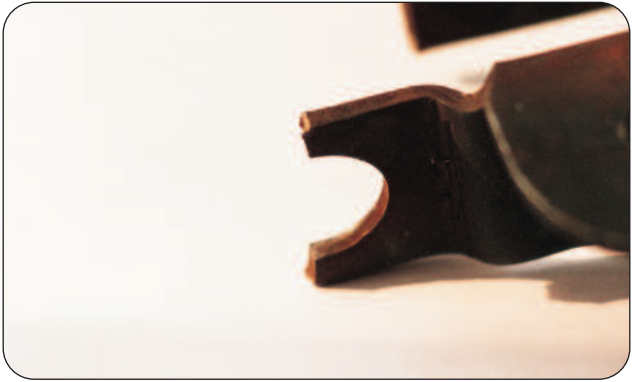
**Figure 43 - Mode of Failure - Tensile overload**

<b>Application:</b>	Bottle washer chain used for washing returned milk bottles in a caustic environment.
<b>Failure Mode:</b>	The chain cranked link has failed in tensile mode.
<b>Diagnosis:</b>	The outer link has been crudely modified which was thinner than the normal inner link.
<b>Solution:</b>	Obtain a properly designed cranked link from Renold.

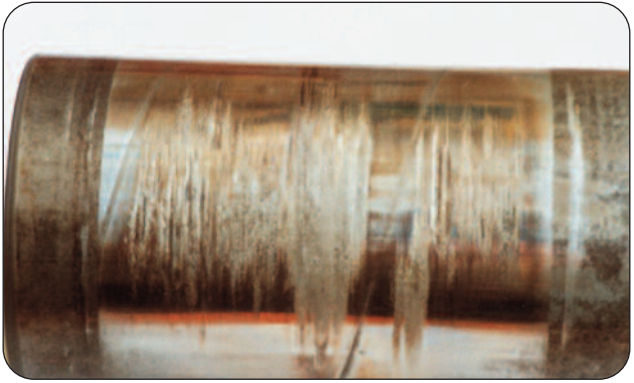
**Figure 44 - Mode of Failure - Galling**

<b>Application:</b>	Hollow pin (step pin) used in a high rise escalator.
<b>Failure Mode:</b>	The pin pressure faces have suffered from severe galling where the surfaces have articulated and fused together.
<b>Diagnosis:</b>	The very high pressures experienced by these high rise escalators have led to squeeze-out and failure of the lubricant allowing the surfaces to touch and gall when the chain articulated.
<b>Solution:</b>	Use high quality, high pressure lubricants and ensure that the lubricant regime is such that the film of lubricant is constantly maintained between the surfaces.

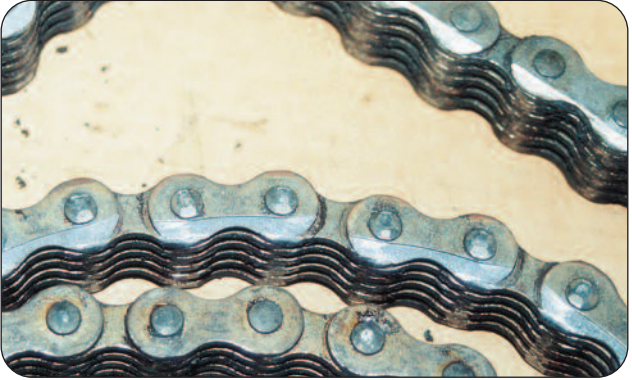
**Figure 45 - Mode of Failure - Alignment**

<b>Application:</b>	1" P 5 x 6 leaf chain used in a counterbalance mechanism for the drivers cab in an overhead crane.
<b>Failure Mode:</b>	Excessive judder noticed by the crane driver.
<b>Diagnosis:</b>	Inspection of the counterbalance arrangement showed that the pulley had worn excessively on one side. This was reflected on one side of the chain. The pulley was found to be out of line with the line of action of the chain attachment points.
<b>Solution:</b>	Renew chain and pulley and realign.

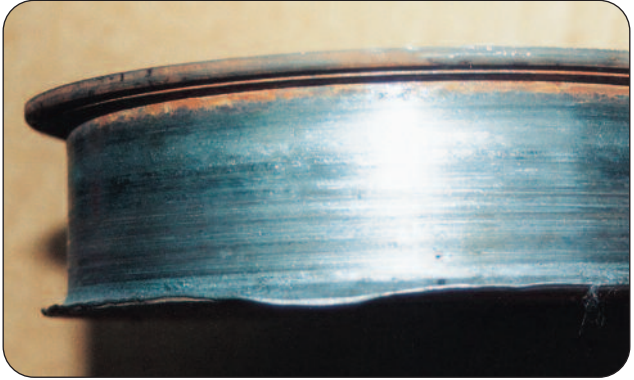
**Figure 46 - Mode of Failure - Alignment**

<b>Application:</b>	1" P 5 x 6 leaf chain used in a counterbalance mechanism for the drivers cab in an overhead crane.
<b>Failure Mode:</b>	Excessive judder noticed by the crane driver.
<b>Diagnosis:</b>	Inspection of the counterbalance arrangement showed that the pulley had worn excessively on one side. This was reflected on one side of the chain. The pulley was found to be out of line with the line of action of the chain attachment points.
<b>Solution:</b>	Renew chain and pulley and realign.

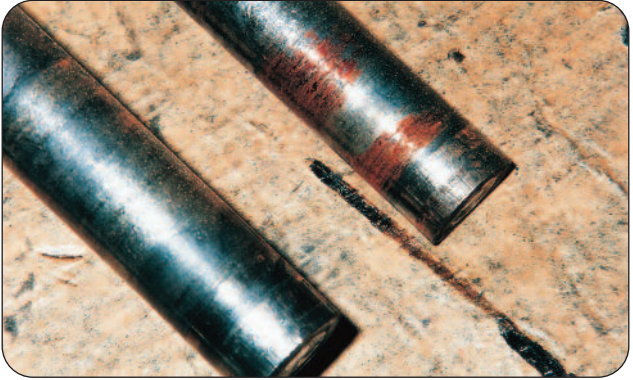
**Figure 47 - Mode of Failure - Galling & fretting corrosion**

<b>Application:</b>	Chain used for a lifting application.
<b>Failure Mode:</b>	Galling and fretting corrosion.
<b>Diagnosis:</b>	The chain being under constant loading at high bearing pressure has resulted in the lubricant being squeezed out between the pin and bush bore. This created a metal to metal contact resulting in a slight galling of the surfaces and the oxidization of the microscopic particles, giving the red oxide deposit. A typical example of fretting corrosion.
<b>Solution:</b>	More frequent lubrication schedule to be introduced.

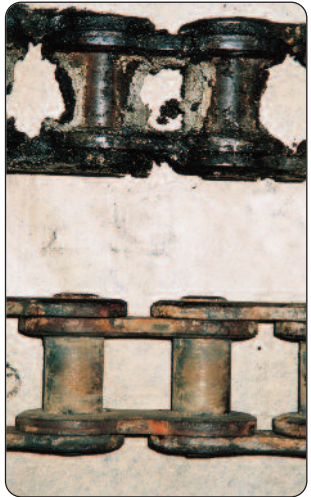
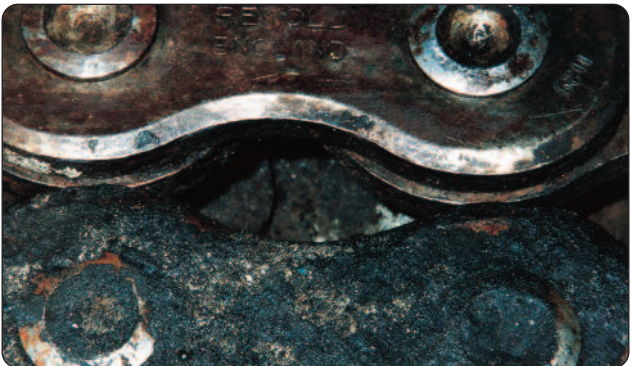
Despite working in a wet environment for over 60 years, the end of life inspection revealed this Renold chain to still be in good condition. This can mainly be attributed to the maintenance schedule undertaken by the customer.
